THE UNITED STATES
STRATEGIC BOMBING SURVEY

THE EFFECTS
OF
THE ATOMIC BOMB
ON
HIROSHIMA, JAPAN

Volume III

Physical Damage Division

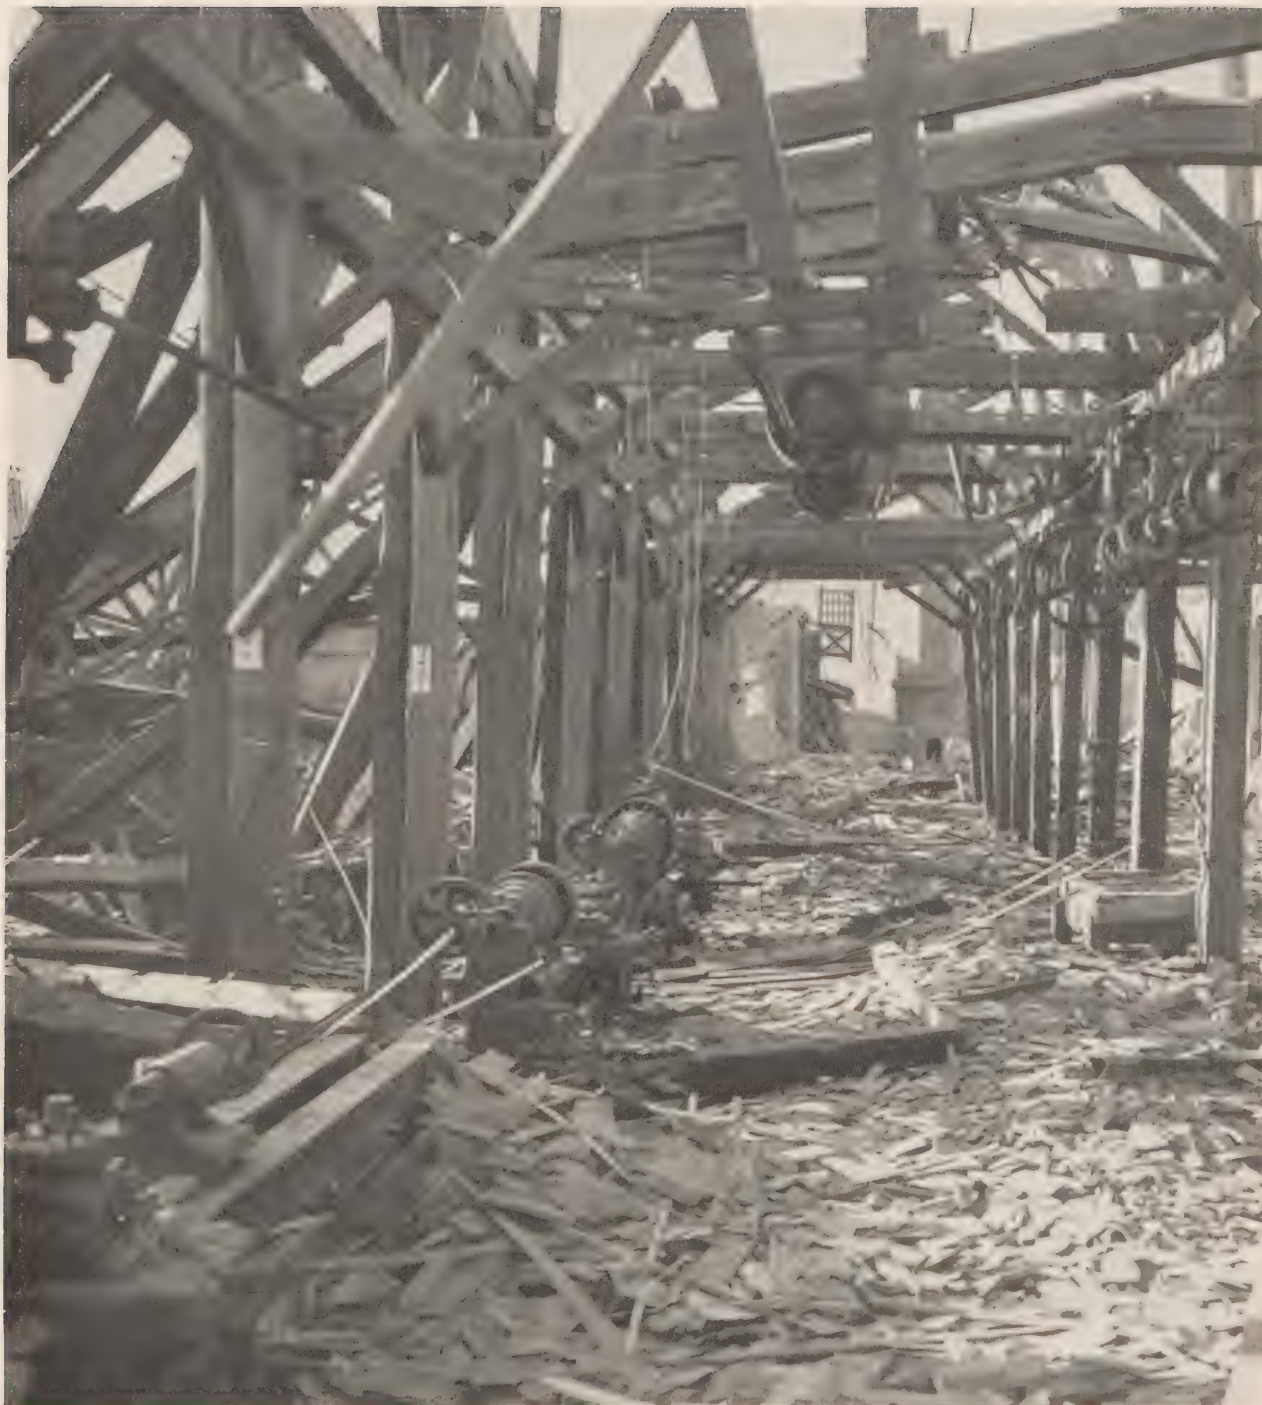
PHOTO 2-XI. Building B, 3,400 feet northwest of GZ, looking west. A congested, wood-frame, light-engineering shop totally damaged by blast. All machine tools seriously damaged, caused mainly by fire which burned debris. Note partly overturned drill press and overhead line shafting thrown over wall away from blast.

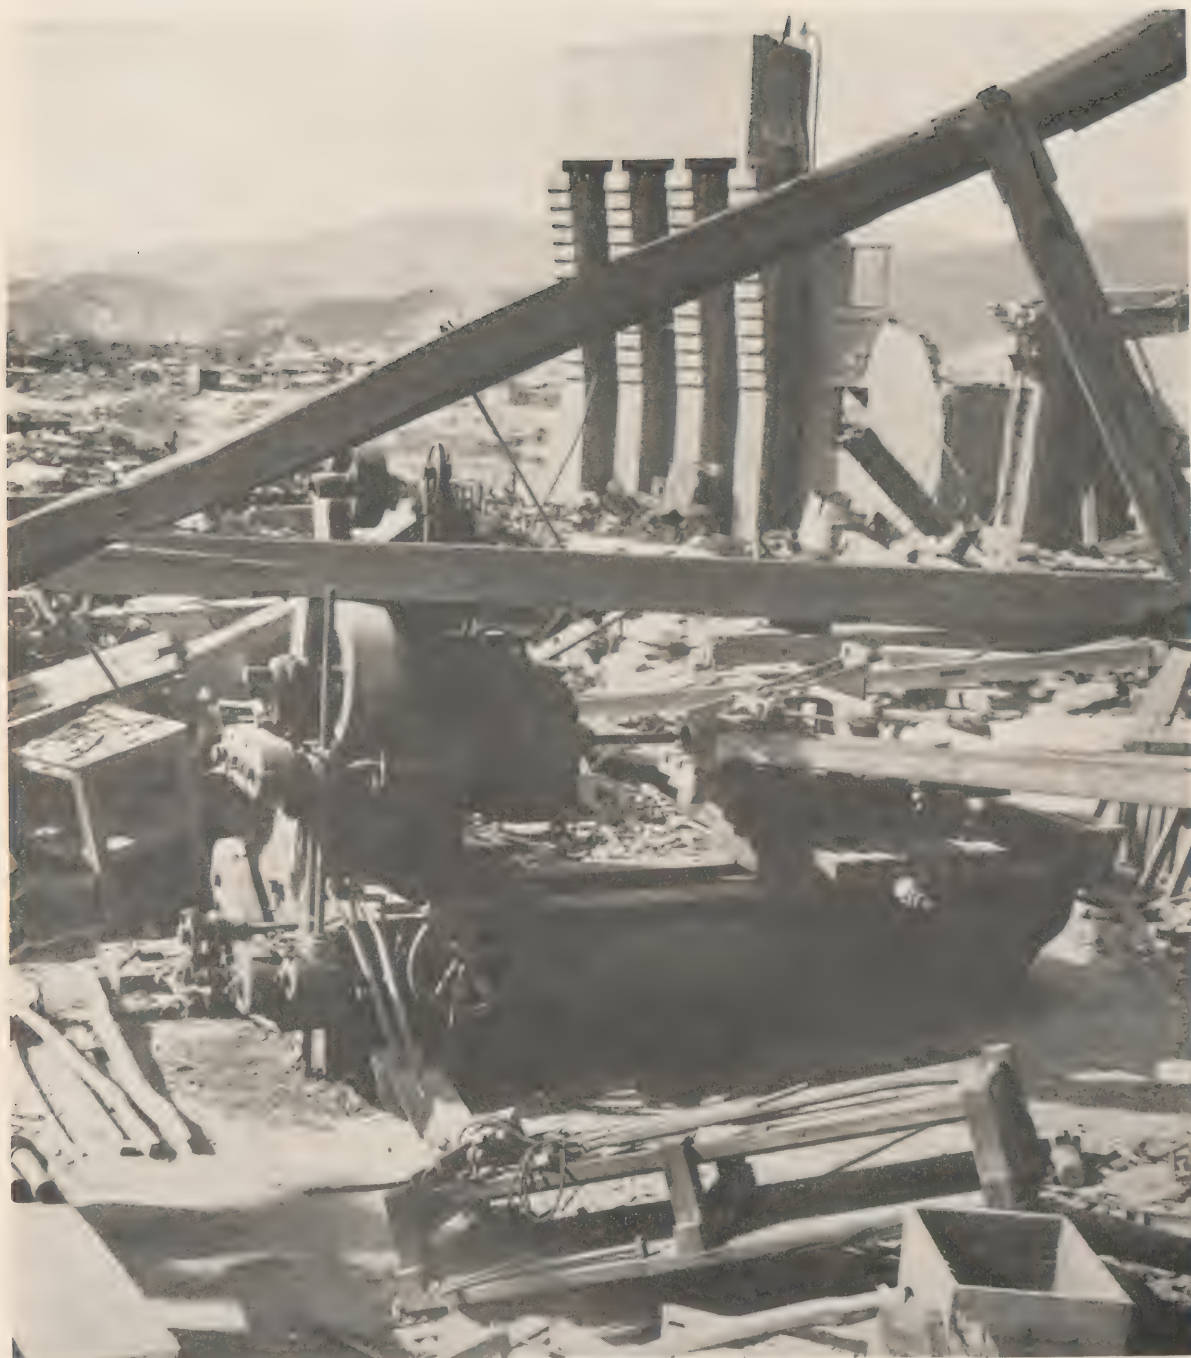
PHOTO 3 XI. Building C, 4,000 feet northwest of GZ, looking west. A wood-frame building about 75 percent structurally damaged by blast. No serious damage to machine tools, no fire in building. Note light combustible debris on floor; machine tools unprotected from weather.

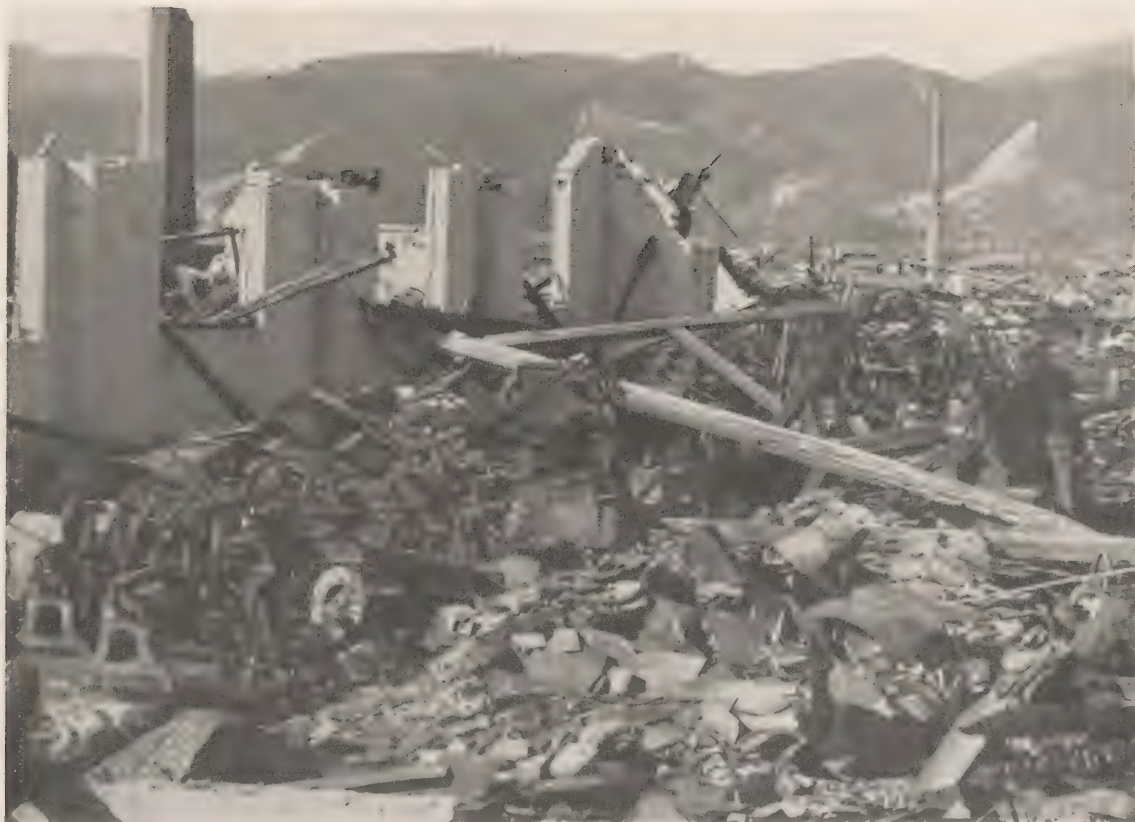
PHOTO 4-XI. Building C, 4,000 feet northwest of GZ, looking southwest. Shows wood truss resting on heavy machine at southwest corner of wood-frame building collapsed by blast. Only slight damage to machine. Note machine unprotected from weather. No fire in building.

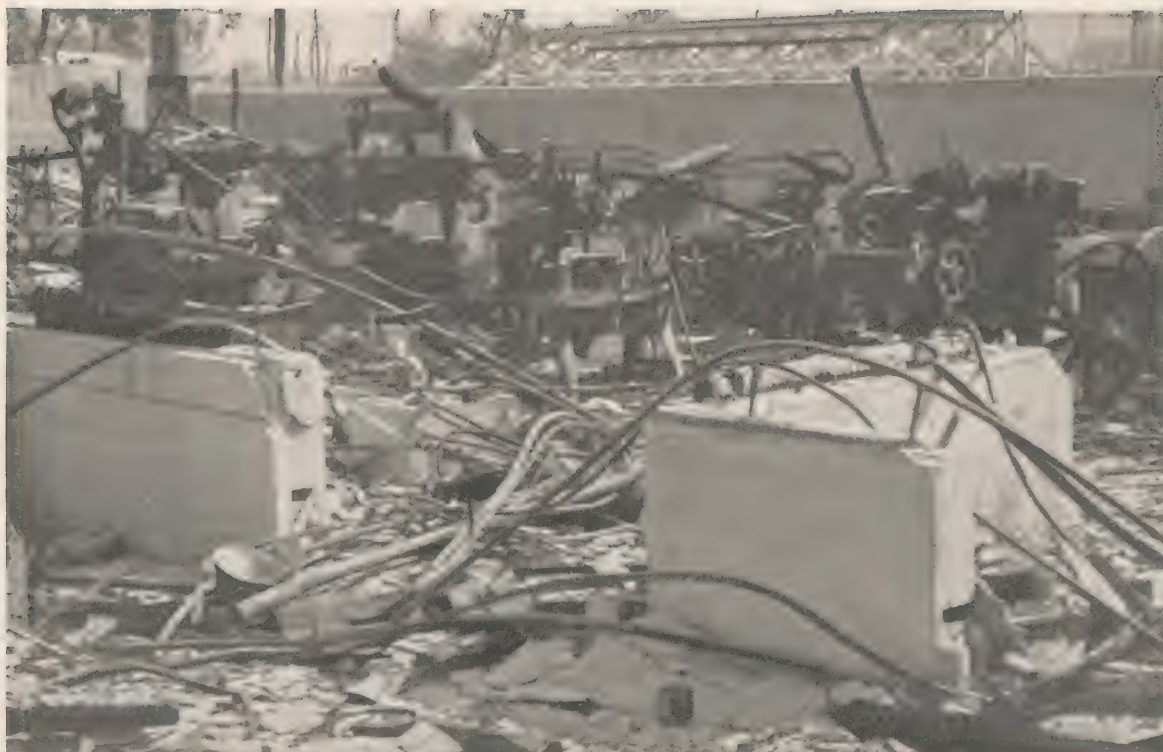
PHOTO 6-XI. Building E, 4,700 feet southwest of GZ, looking northwest. A wood-frame, light-engineering shop destroyed by blast. Serious damage entirely by fire which burned combustible debris. Note milling machine at right overturned when blast collapsed building. Press in center partly overturned in same manner.

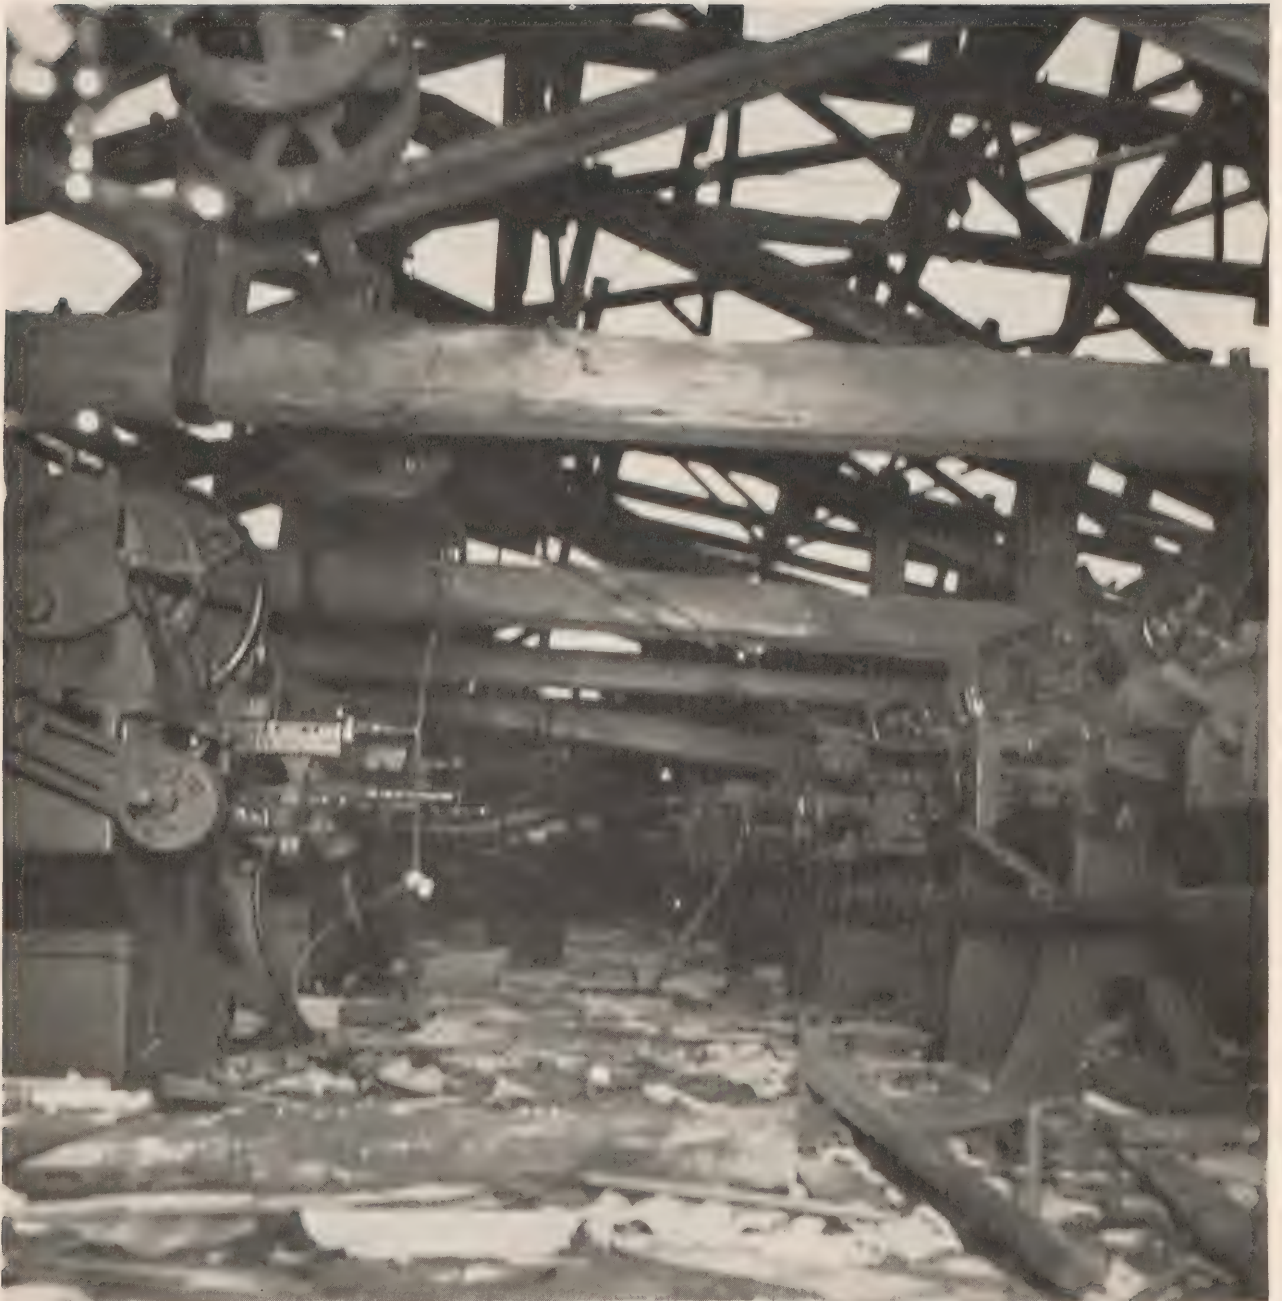
PHOTO 8-XI. Building H, 6,500 feet southeast of GZ, looking northwest. A wood-frame, light-engineering shop structurally damaged by blast. Ensuing fire caused most of serious damage to machine tools. Note cracked concrete base of small lathe at left.

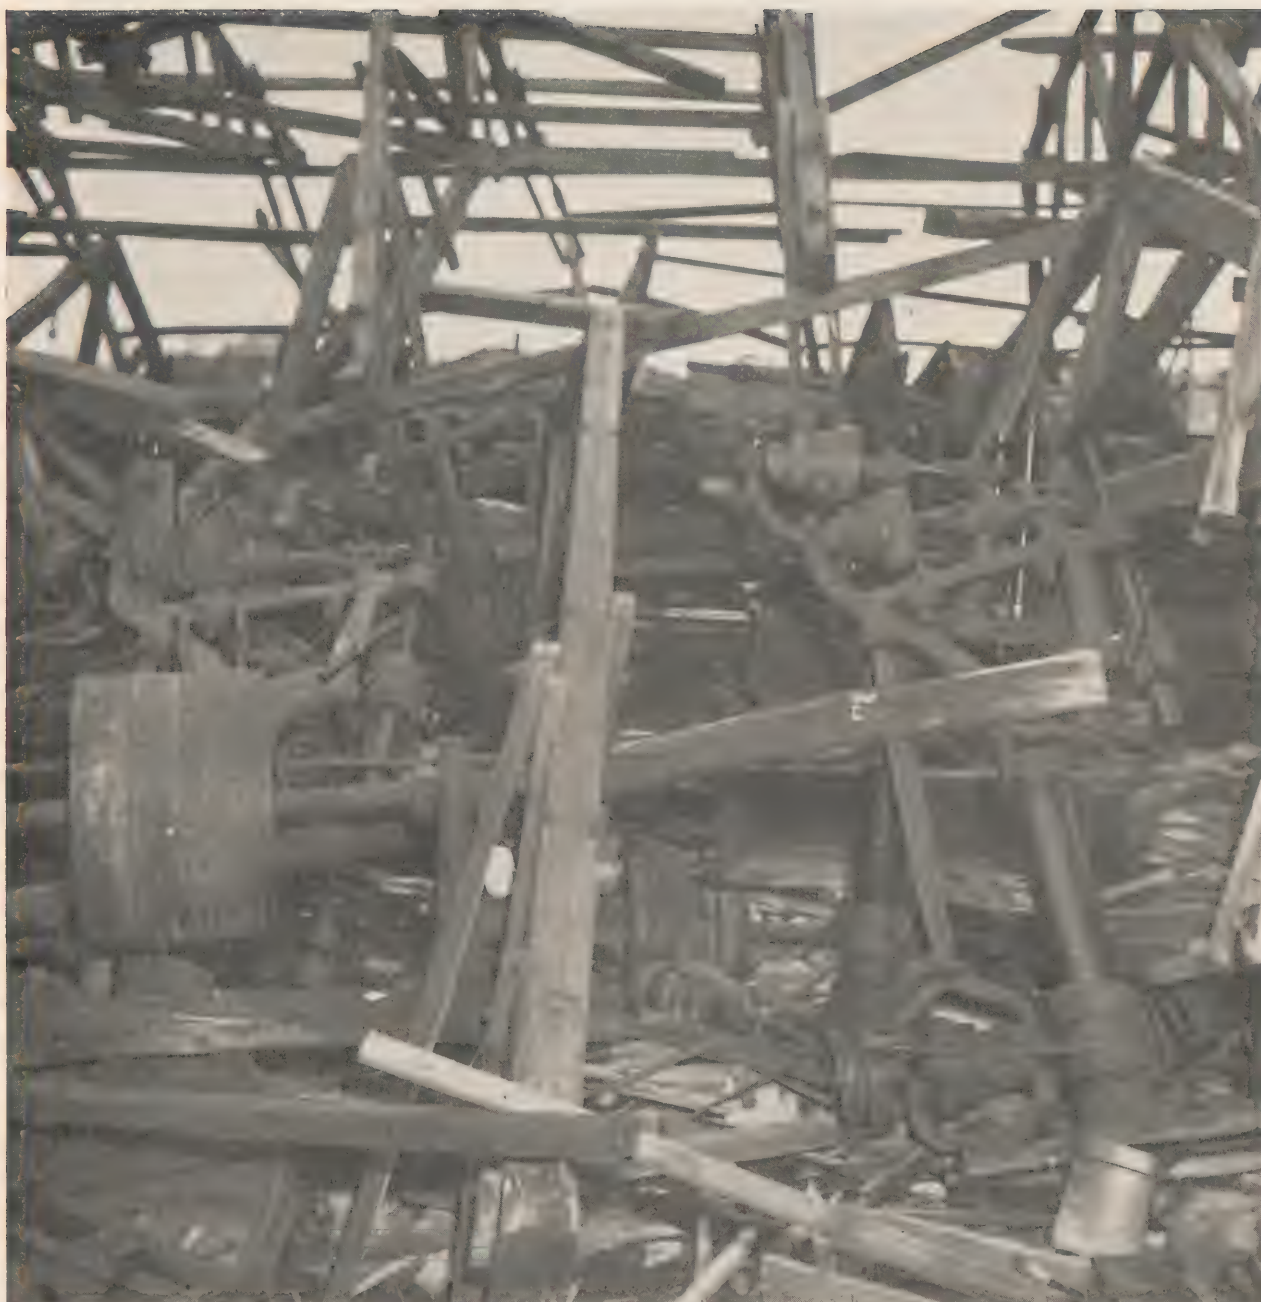
PHOTO 9 XI. Building G, 6,000 feet south of GZ, looking west. A wood-frame, light-engineering shop collapsed as a unit by blast (no fire). Wood trusses had lateral motion imparted by blast and came to rest on lathes, damaging them only slightly. These machine tools were given a protective coating of grease soon after the atomic-bomb attack.

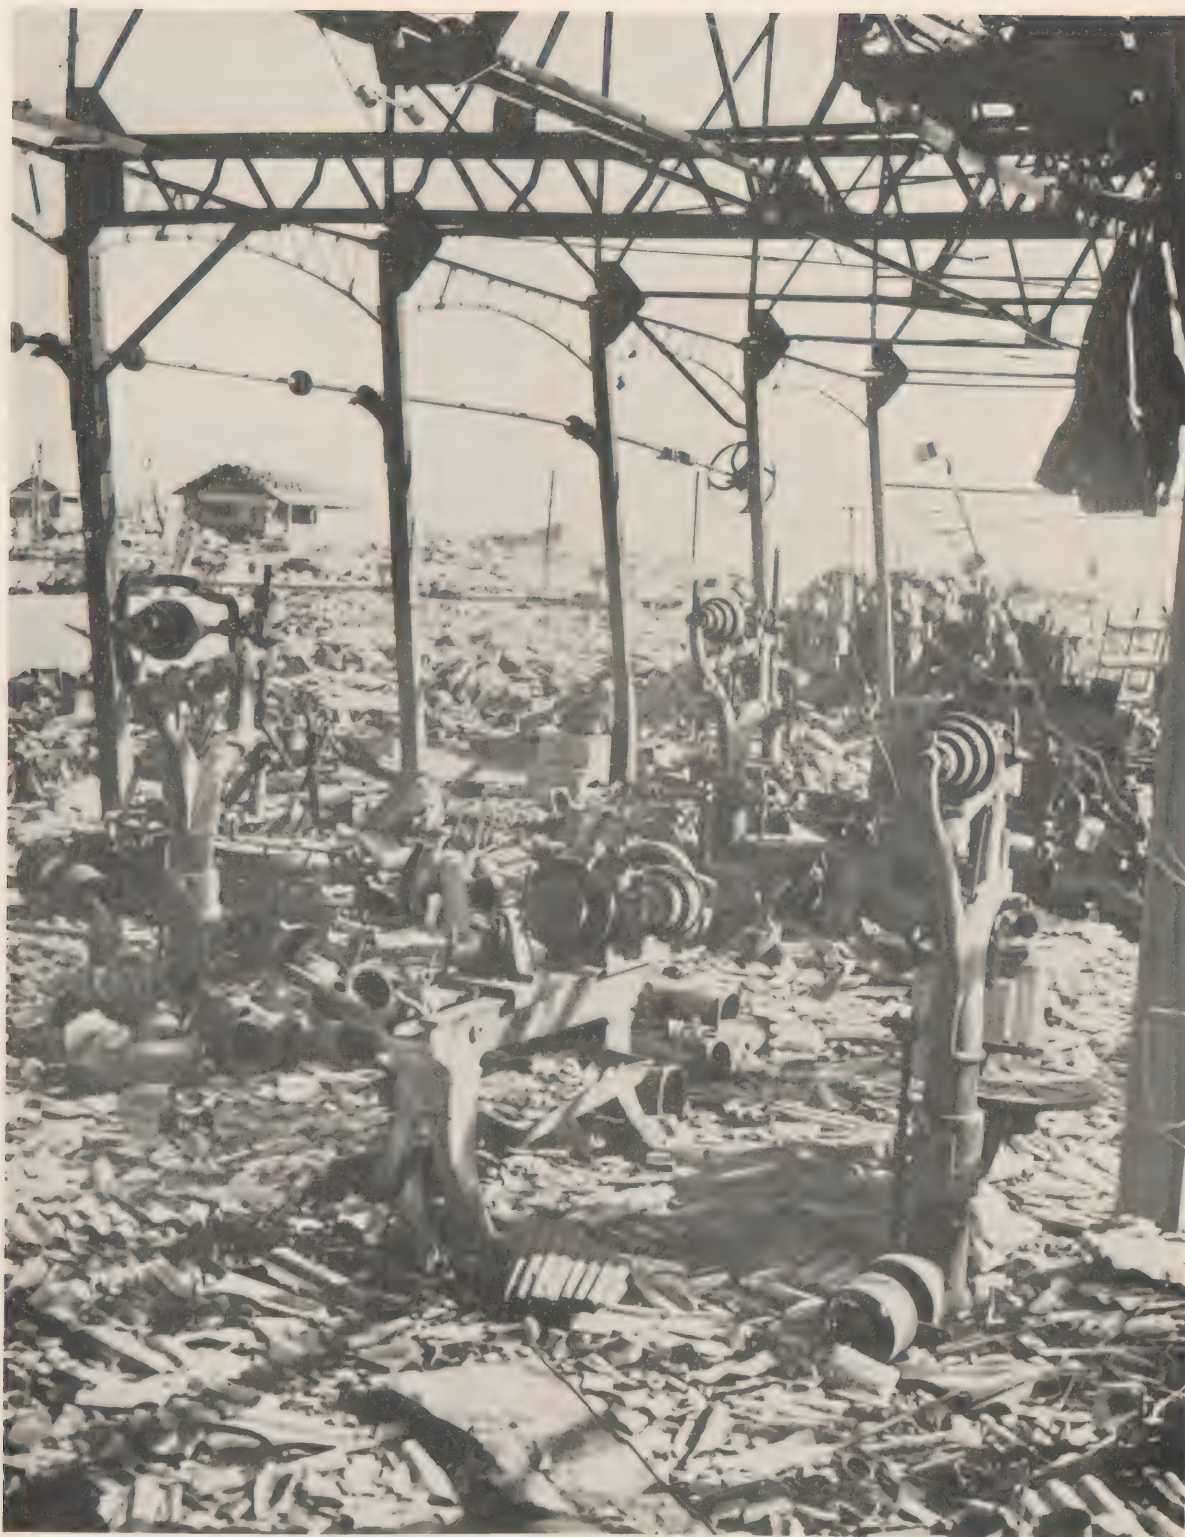
PHOTO 16-XI. Building N, 1,800 feet east of GZ, looking north. A steel-frame, noncombustible repair shop structurally damaged by blast. Drill press and lathe seriously damaged by fire in combustible floor and contents. Note rubber tires on bicycles burned.

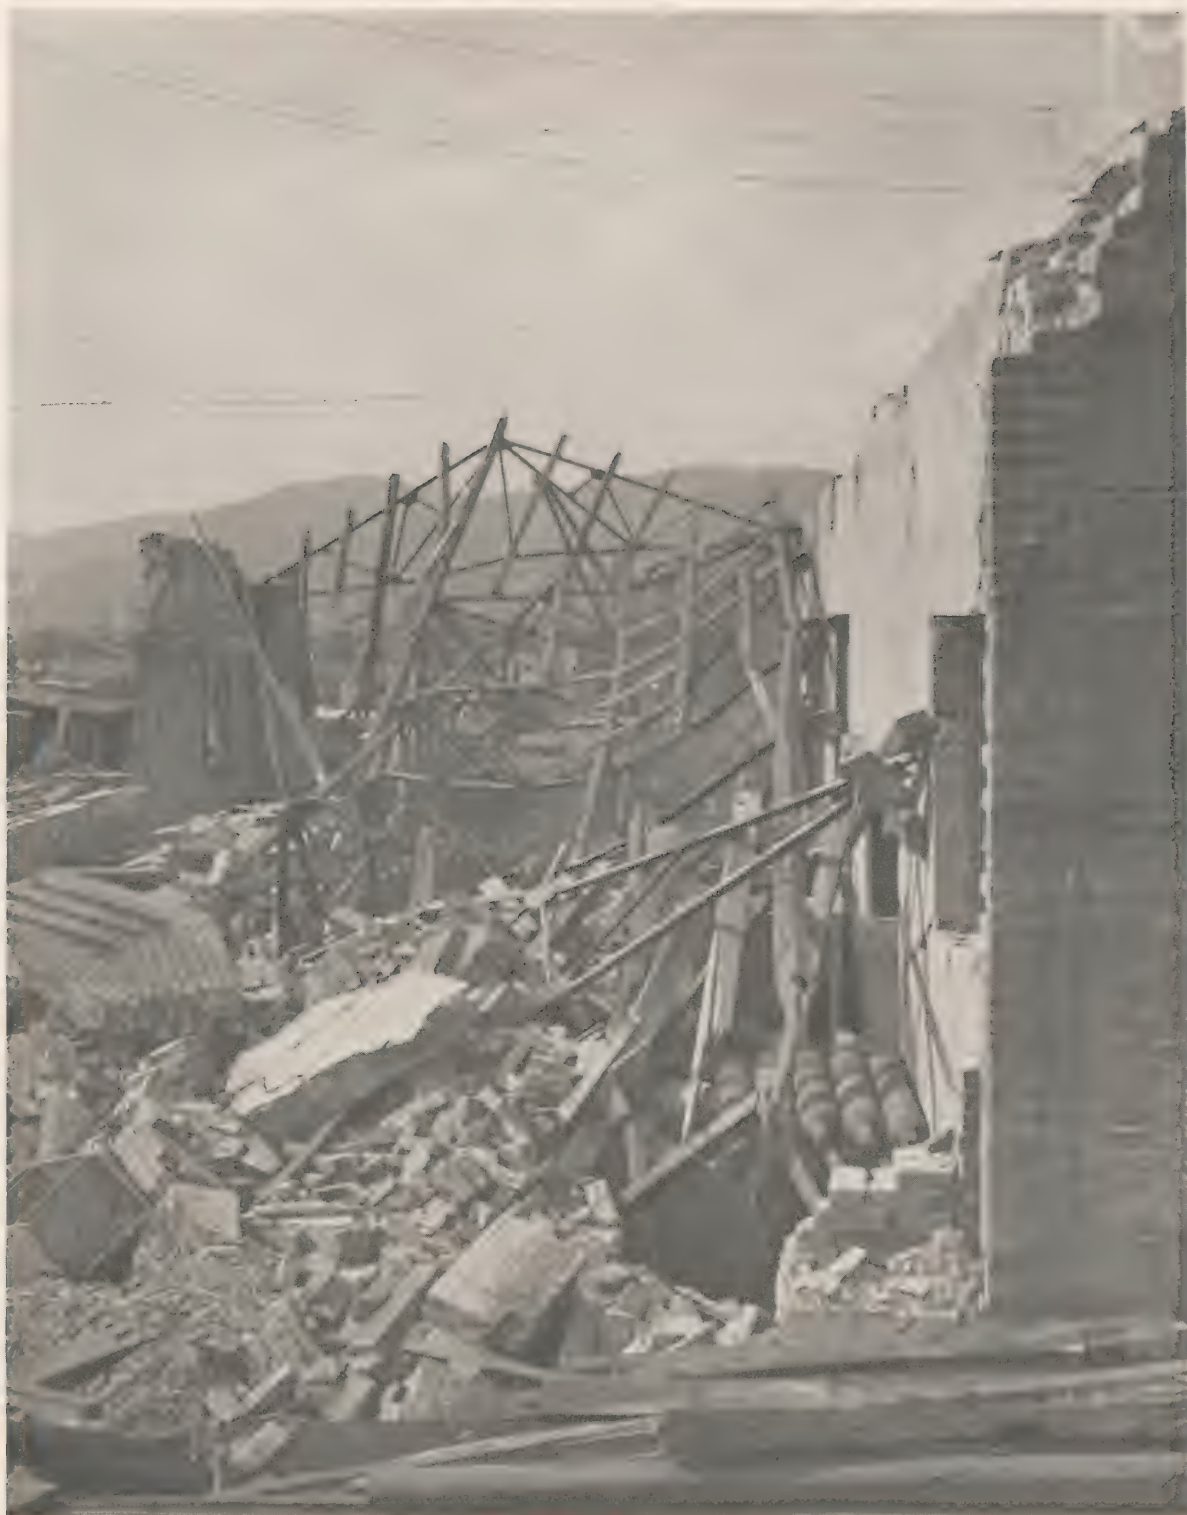
PHOTO 19-XI. Building R, 4,700 feet west of GZ, looking east. A steel-frame, combustible, heavy-engineering shop about one-half structurally damaged by blast. No damage to machine tools by blast or debris. No fire.

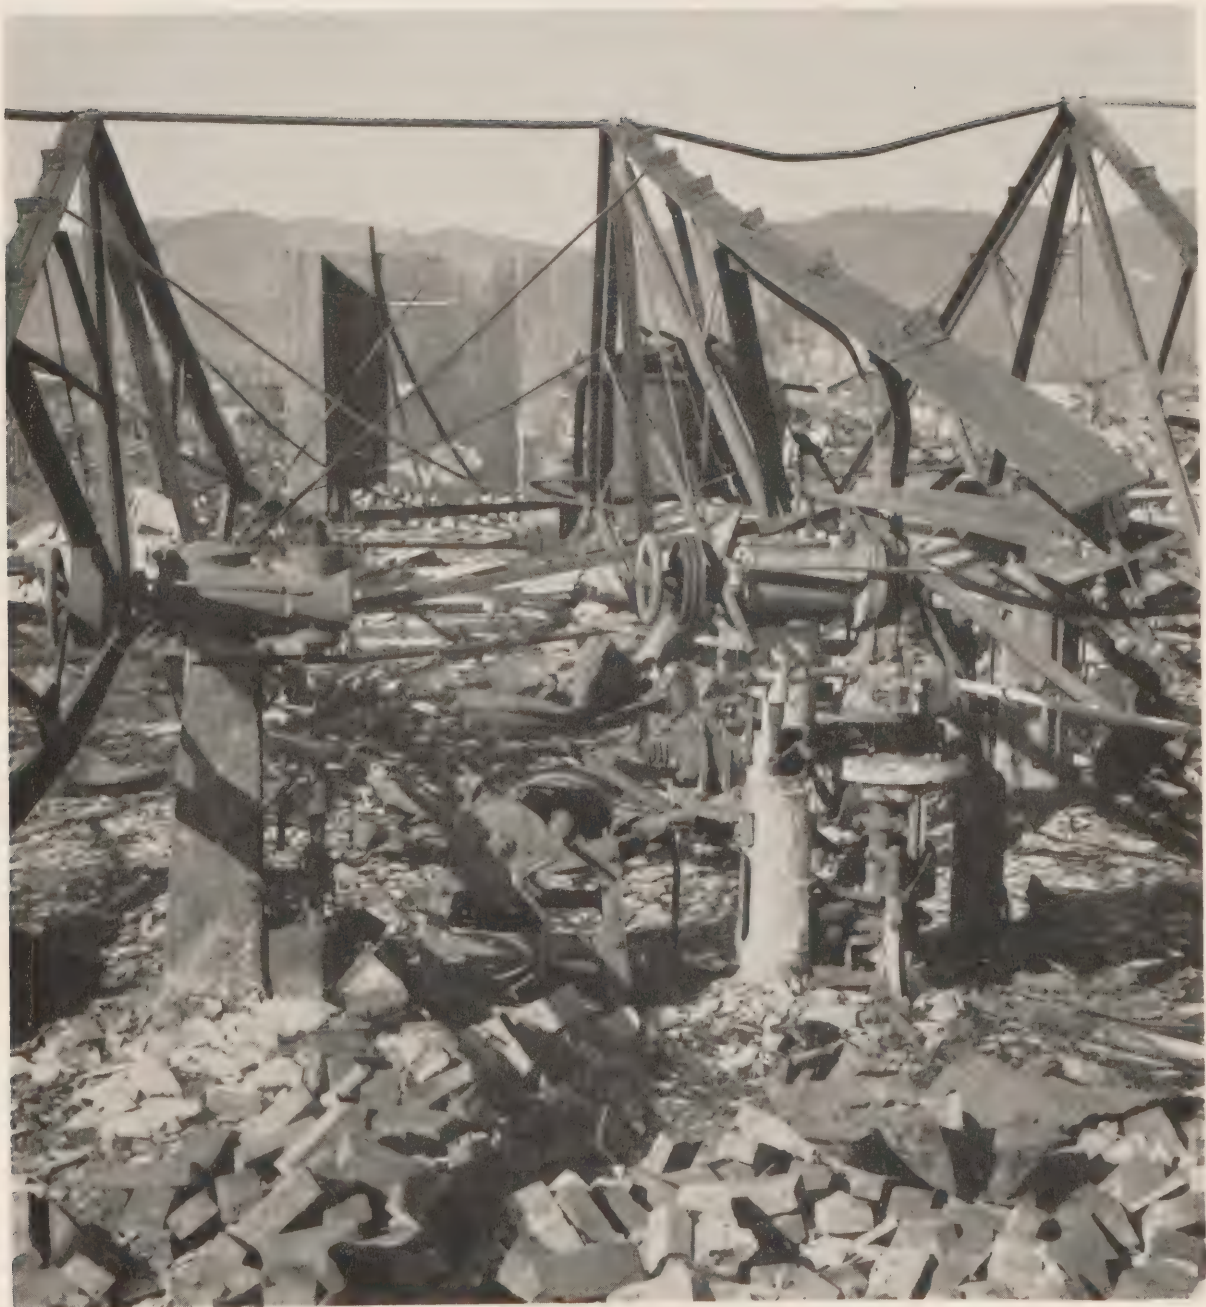
PHOTO 20-XI. Building T, 4,000 feet northwest of CZ, looking west. A small, combustible machine shop with load-bearing brick walls. South and east walls, which faced blast, and roof were collapsed into building by blast, totally or heavily damaging 75 percent of machine tools. Remainder of machine tools slightly damaged by weather. No fire.

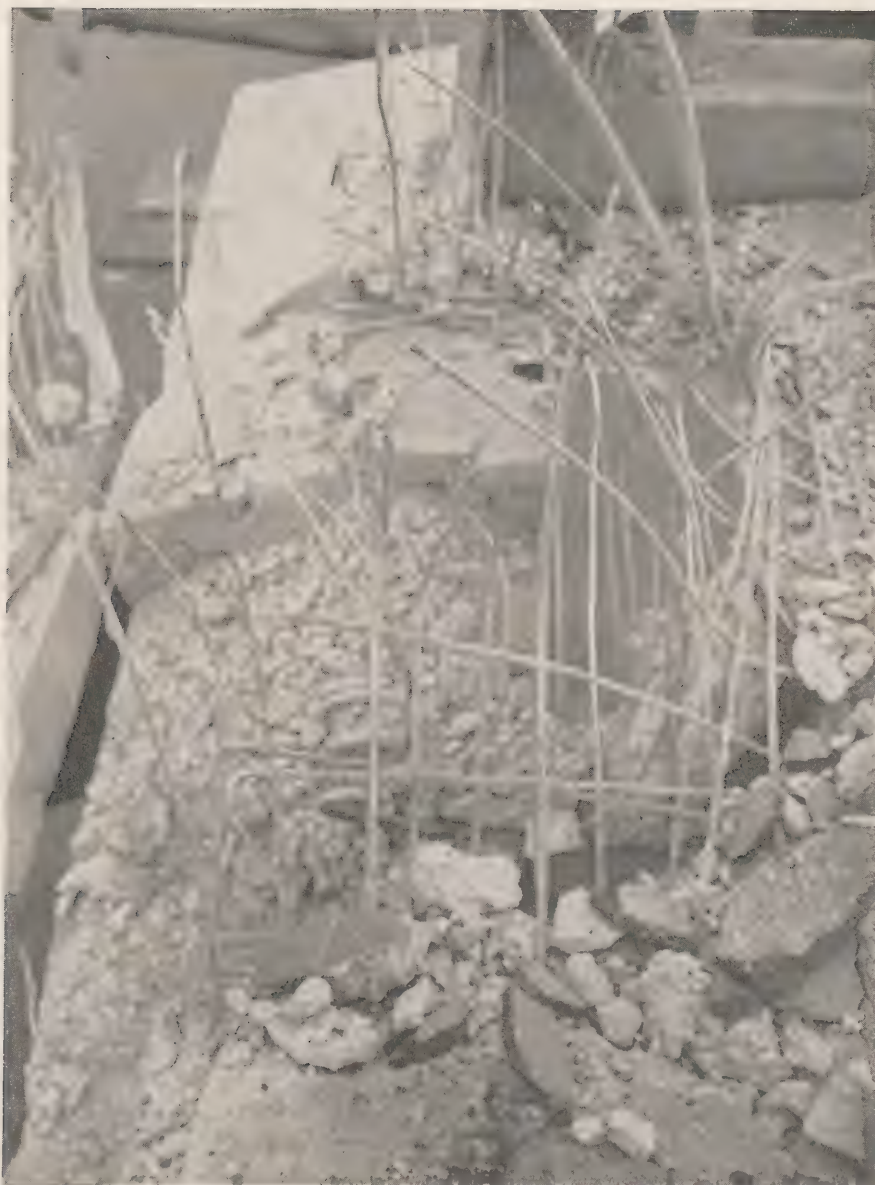
PHOTO 4 XII. Bridge 3. Looking west at flood-damaged, highway bridge over the Enko-Gawa. Water main carried by bents (7,130 feet to GZ, 7,390 feet to AZ).

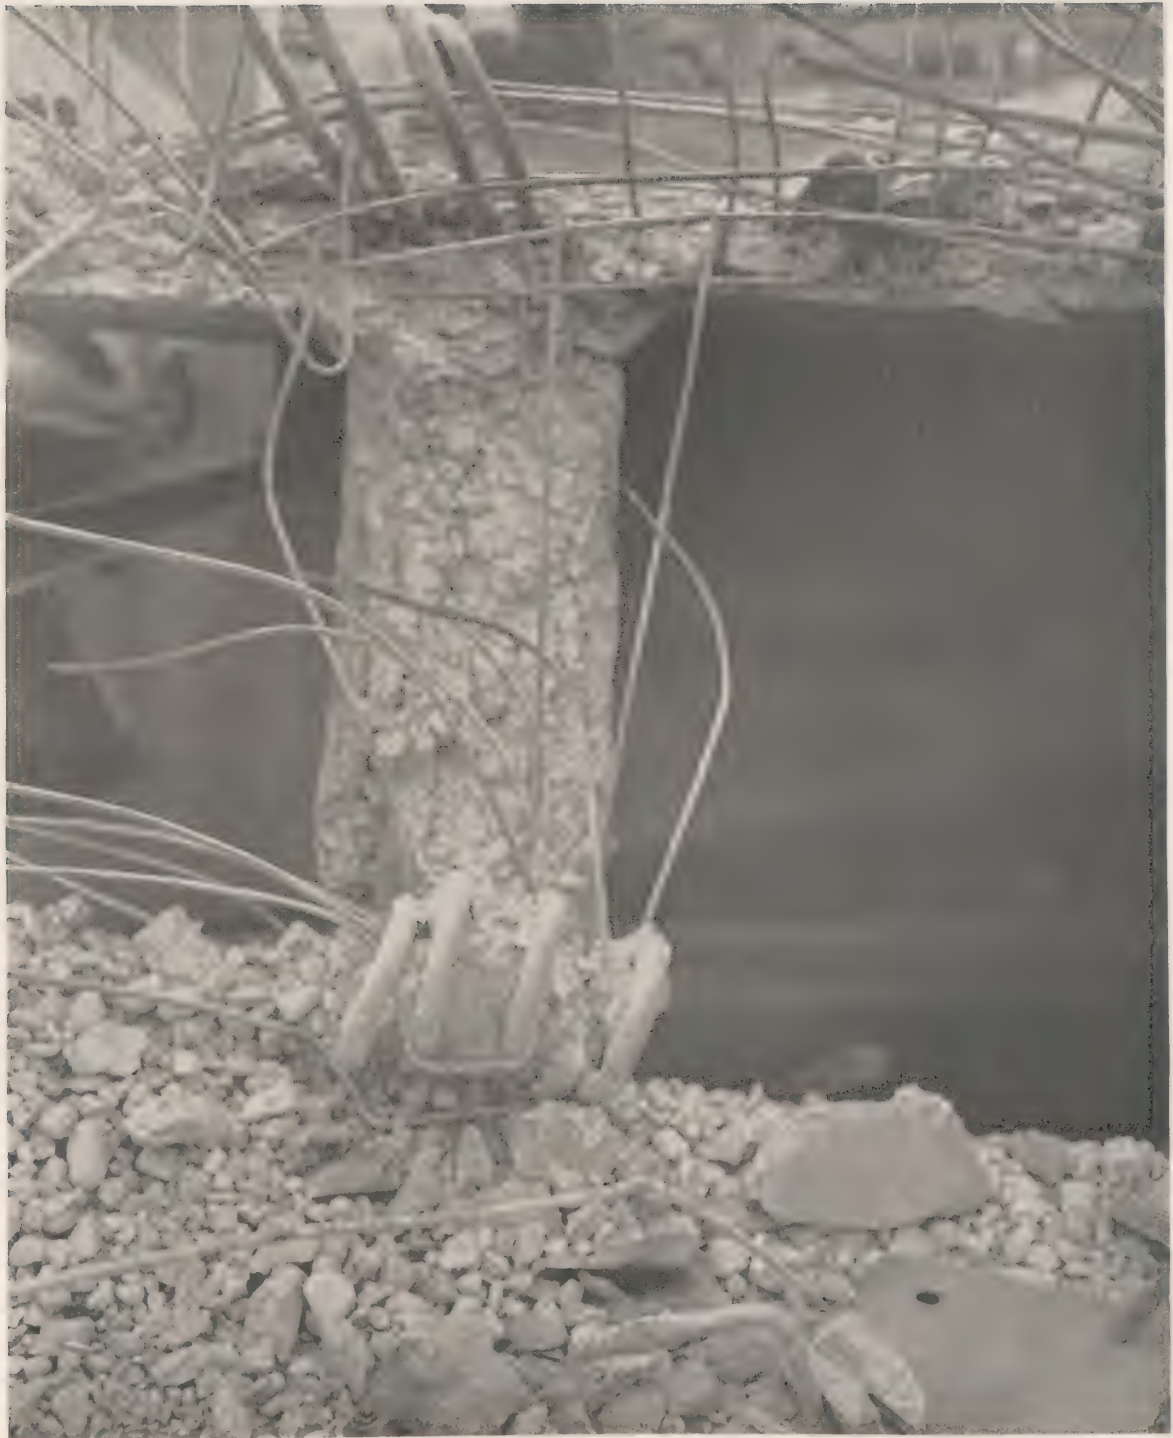
PHOTO 5-XII. Bridge 3. Reinforcing steel exposed at section of break in deck girder.

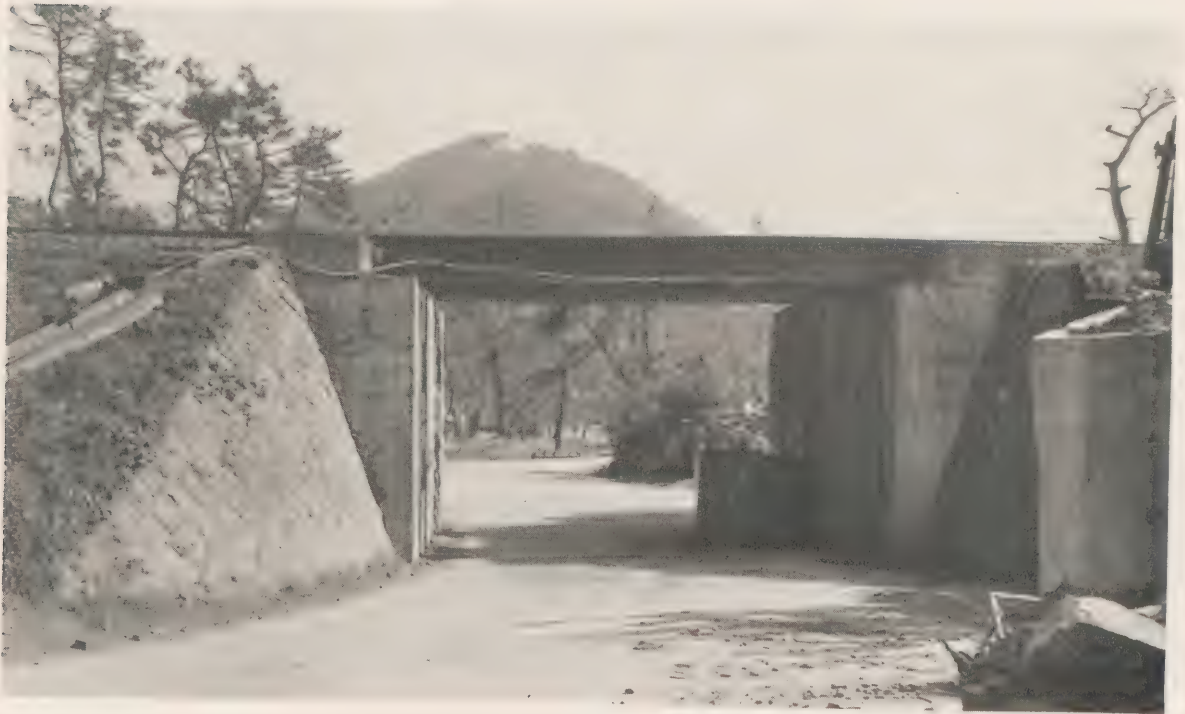
PHOTO 13-XII. Bridge 8. South elevation of bridge over Kyobashi-Gawa. Superficial blast damage to concrete railings (5,390 feet to GZ, 5,700 feet to AZ).

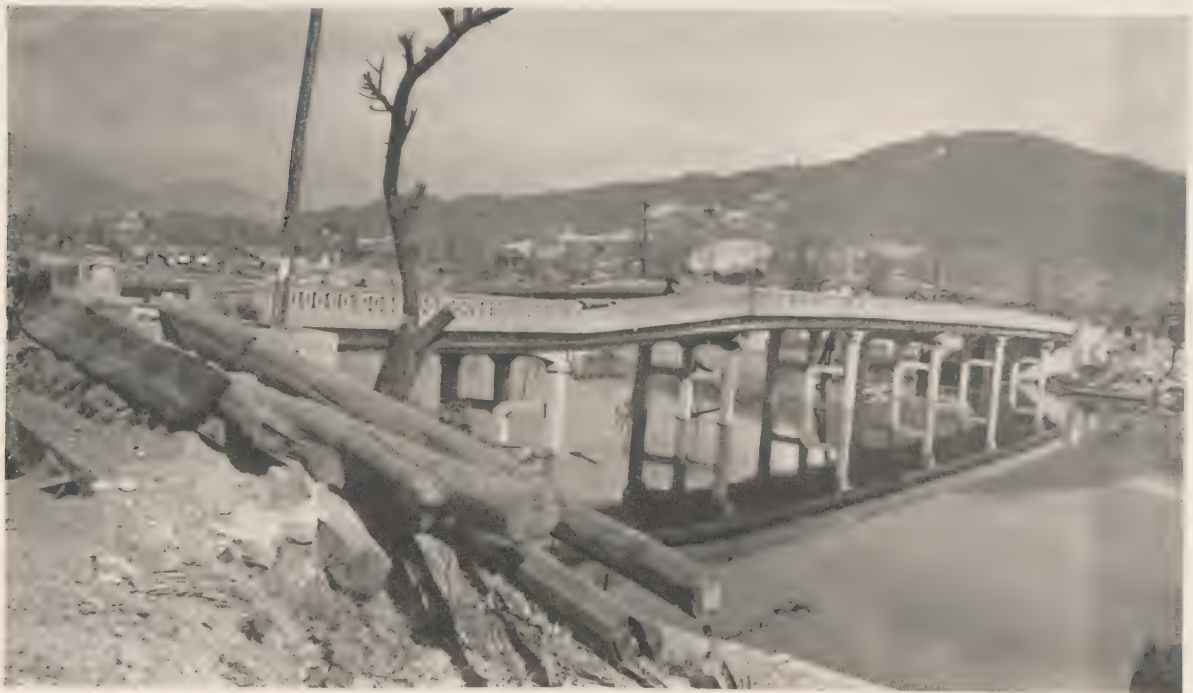
PHOTO 17-XII. Bridge 9. Paint on north elevation of steel girders unaffected by bomb.

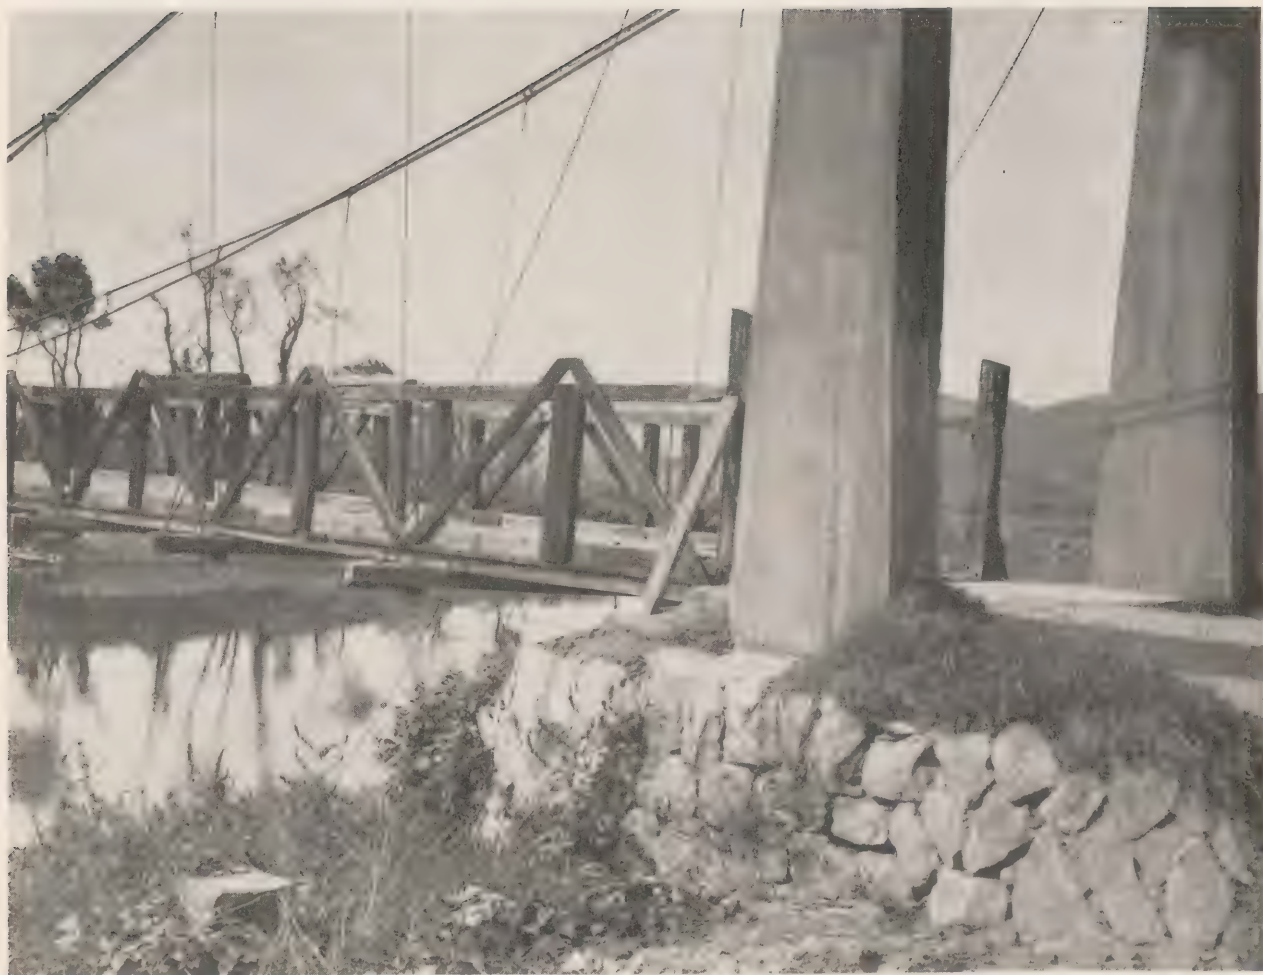
PHOTO 18-XII. Bridge 10. East elevation of bridge over Kyobashi-Gawa showing flood damage (6,950 feet to GZ, 7,250 feet to AZ).

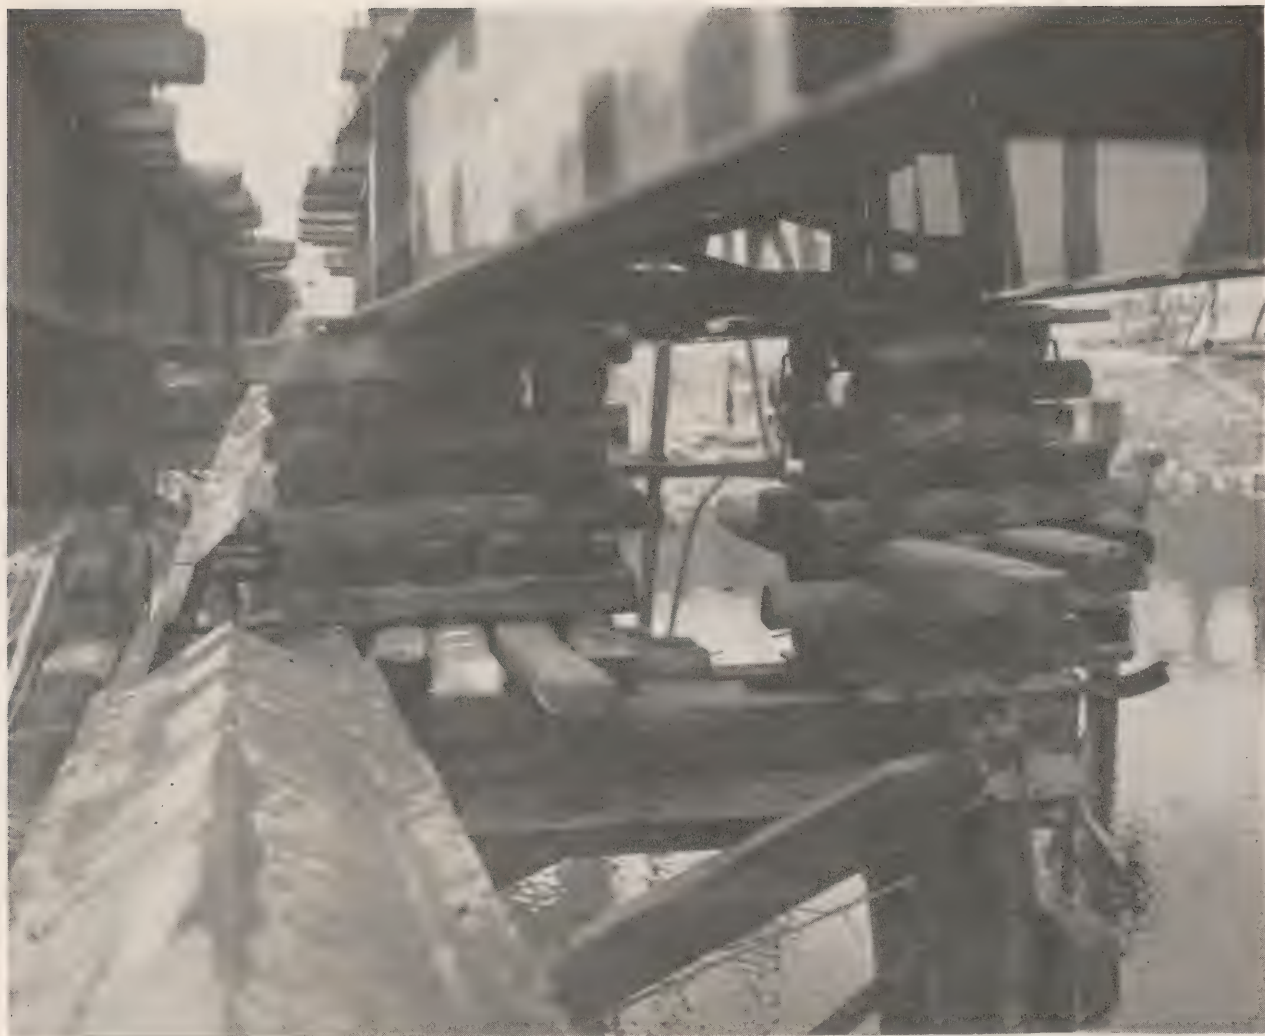
PHOTO 27-XII. Bridge 13. Timber cribbing under trolley tracks at fourth span from east abutment of blast-and flood-damaged bridge over the Kyobashi-Gawa (4,670 feet to GZ, 5,080 feet to AZ).

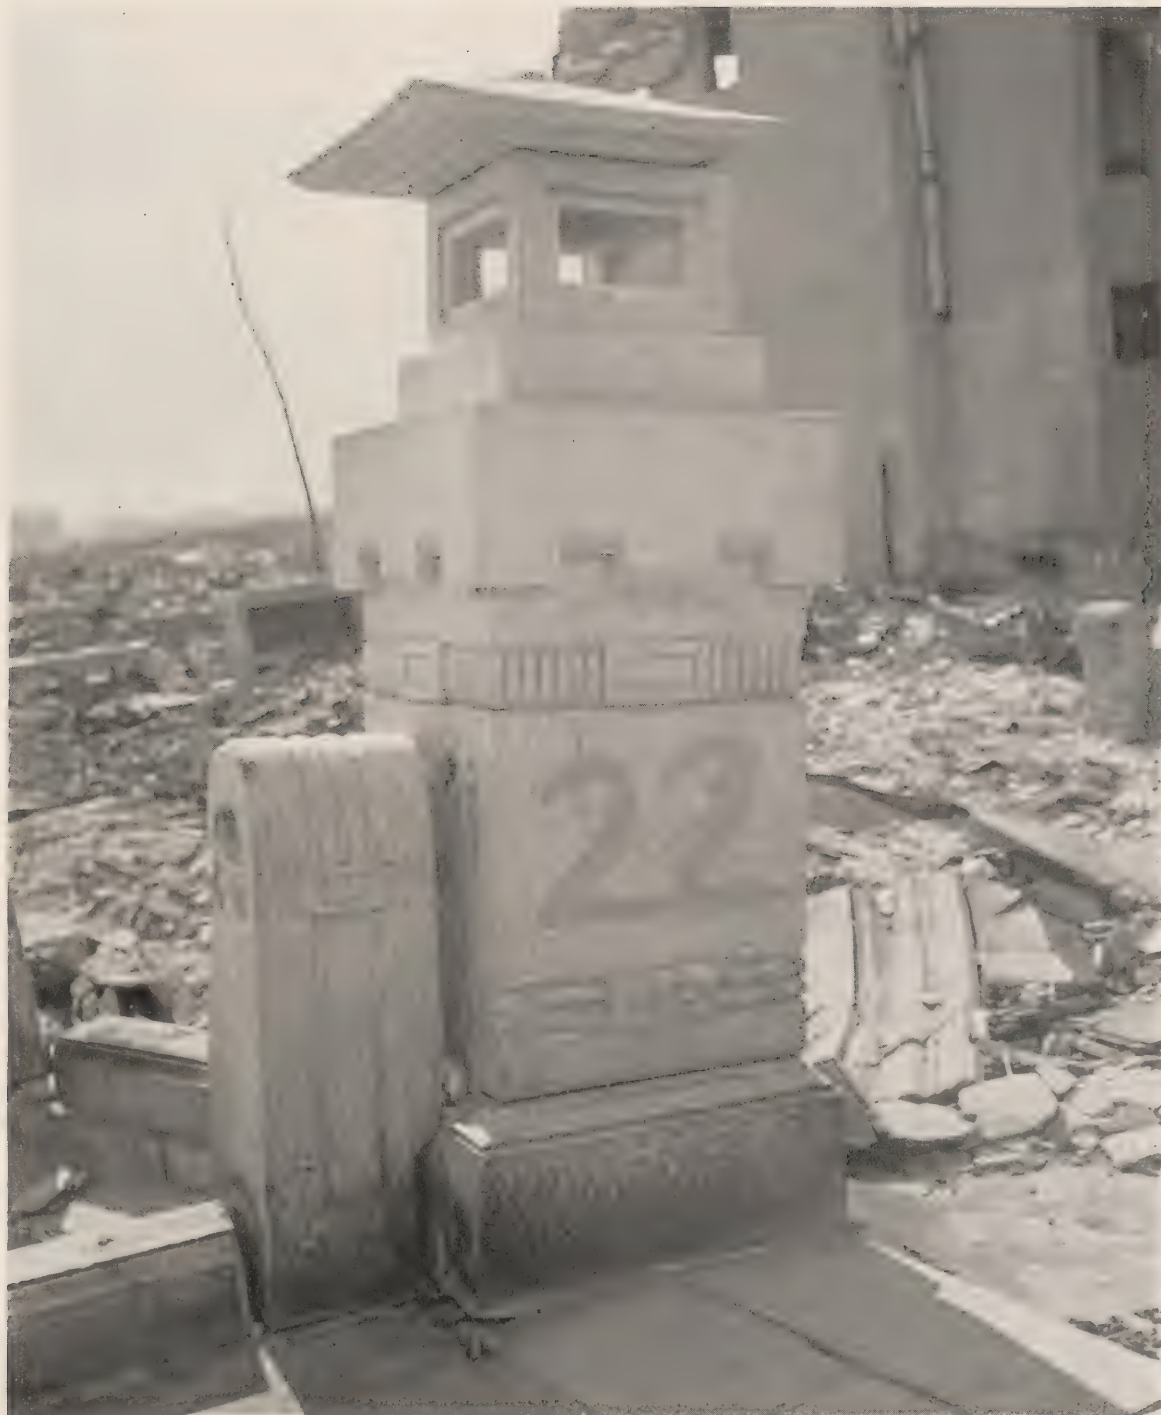
PHOTO 45-XII. Bridge 22. Stone posts and railing damaged by blast (260 feet to GZ, 2,020 feet to AZ).
